# Manhole Inspection Summary

Manhole # S15YY\_003MH

Insp Date: **3/22/07 9:56 AM**

**Location** Address: **3531 REISTERSTOWN RD**

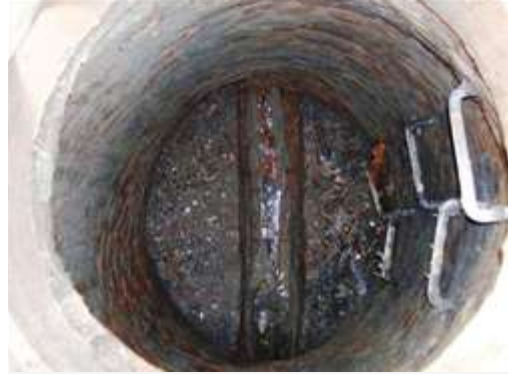
Top View

Evidence of surcharge - Bench debris.  
Channel debris.

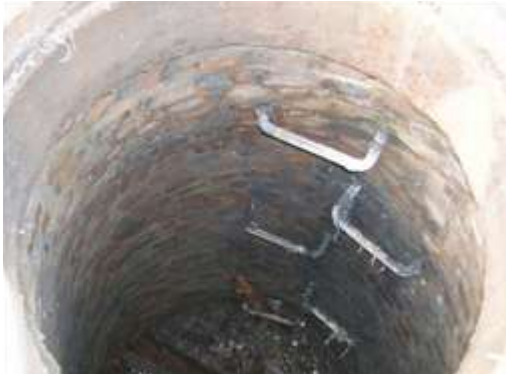
Defect

Frame leaks. Adjustment deterioration  
and infiltration. Corbel and Barrel  
infiltration - other side.

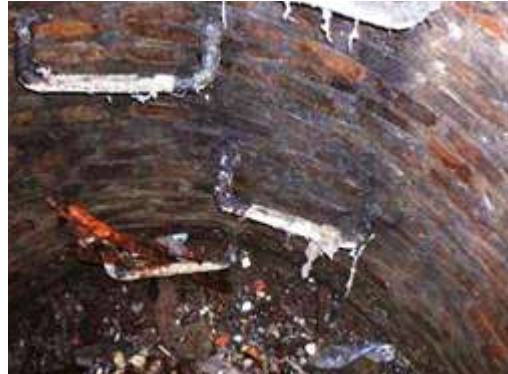
Defect

Coroded steps.

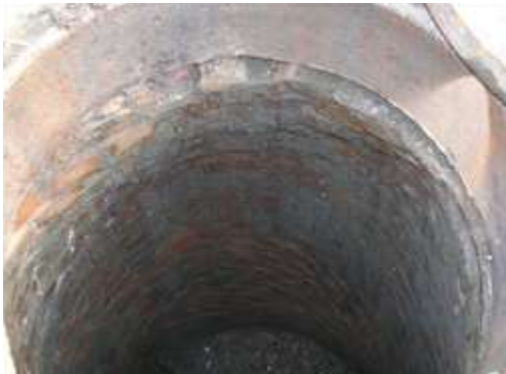
Defect

Frame leaks. Adjustment deterioration  
and infiltration. Corbel and Barrel  
infiltration.

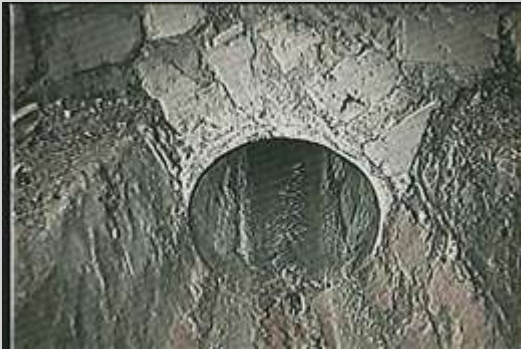
Pipe Out @ 12 O'Clock

Barrel deterioration and infiltration. Channel deterioration.

Deposits: ☐ None ☐ Mud ☐ Sludge ☐ Debris ☒ Grease

Infiltration: **Evidence** Pipe Seal Cond: **Unknown**

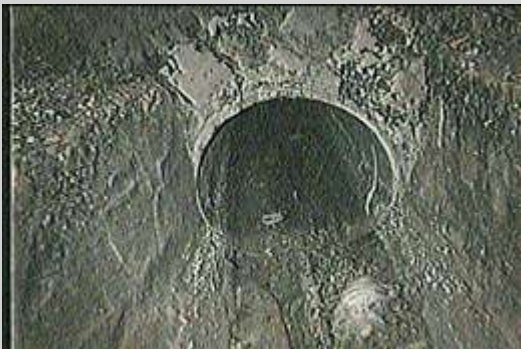
Pipe In @ 6 O'Clock

Infiltration: **Evidence** Pipe Seal Cond: **Cracked**
